Review of Electrocution Deaths in Iraq:
Part II - Seventeen Incidents Apart from
Staff Sergeant Ryan D. Maseth, U.S. Army

SUBJECT: Review of Electrocution Deaths in Iraq: Part II – Seventeen Incidents Apart
From Staff Sergeant Ryan D. Maseth, U.S. Army (Report No. IPO2009E001)

**Review of Electrocution Deaths in Iraq:
Part II – Seventeen Incidents Apart from
Staff Sergeant Ryan D. Maseth, U.S. Army
(Report No. IPO2009E001)**

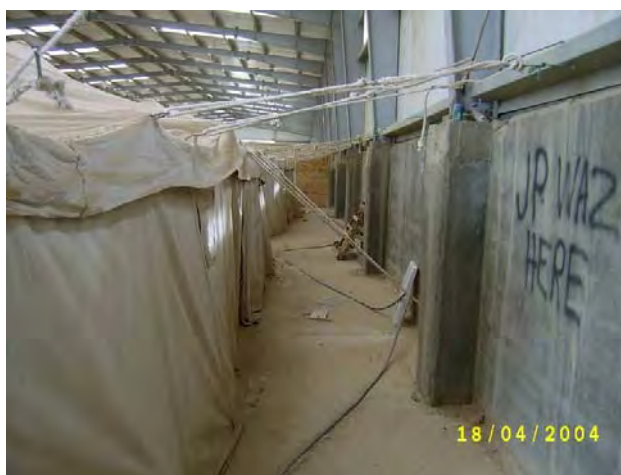
Specialist Campo-Siles was a trained and experienced generator repairman. On April 17, 2004, he and two other soldiers were performing maintenance on a generator supplying electrical power to two warehouse-like structures that housed U.S. soldiers on Forward Operating Base Brassfield -Mora. The generator was functioning, but the housing units were not receiving electrical power. The team checked voltage at the breaker box and concluded that electricity was not flowing through the breaker box. While Specialist Campo-Siles remained at the breaker box, the two other soldiers began following the wires to determine where the electrical “drop off” was occurring. The wiring from the generator (located outside the housing unit) and the interior of the housing area are shown in the figure below.

**Figure 2. Generator Cable and Housing Unit
Involved in Specialist Campo-Siles Electrocution
(From Army Photographs)**

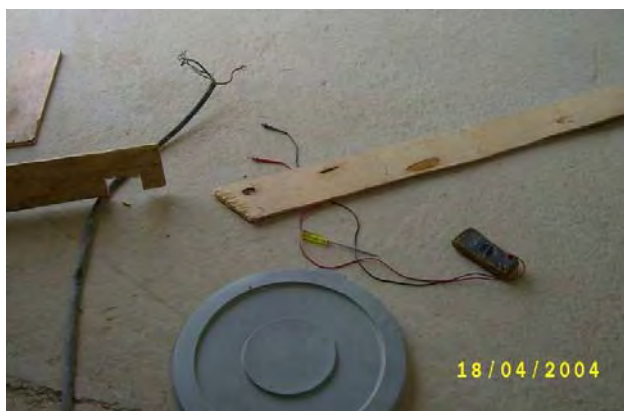
Shortly after leaving Specialist Campo-Siles, the two other soldiers heard a scream and, upon checking, discovered Specialist Campo-Siles lying on the ground. He apparently had disconnected wires from the breaker box and was holding live electrical wires in his hands. A yellow screwdriver apparently used for the disconnections was found near the electric meter. The incident site is shown in the figure below.

**Figure 3. Site Where Specialist Campo-Siles
was Electrocuted (From Army Photographs)**

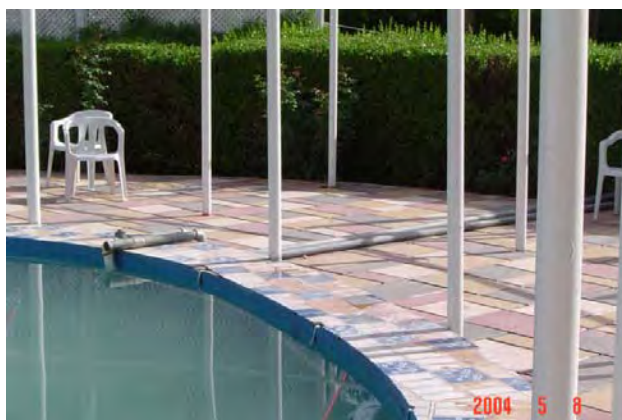
Specialist Chase R. Whitham was electrocuted while swimming in an outdoor pool at Forward Operating Base Patriot, Mosul, Iraq, on May 8, 2004. The site is shown in the figure below.

Figure 4. Pool Where Specialist Whitham was Electrocuted (From Navy Photographs)

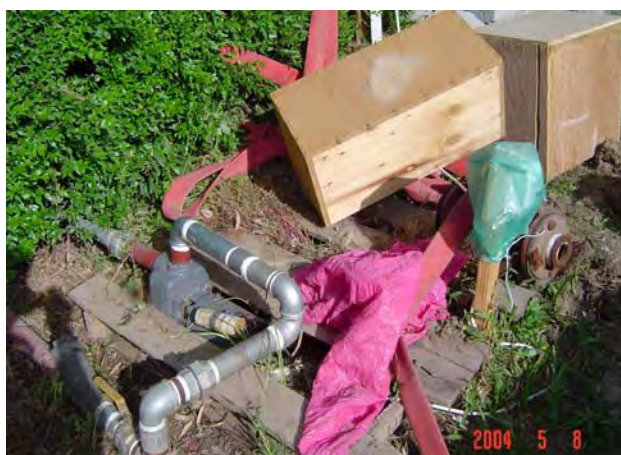
- **Water Pump:** The pump was located above ground, adjacent to a fuse box, and connected a water supply pipe, which continued to the pool, to a second above ground pipe, which also continued to the pool. The pipes were both 3-inch diameter metal pipes that extended about 20 feet through a hedge to the North swimming pool West side. Report of investigation photographs indicate boxes made of wood/lumber covered the pump and fuse box, as shown in the figure below.

**Figure 5. Covers for Pump and Fuse Box
in Area Where Specialist Whitham was Electrocuted
(From Navy Photographs)**

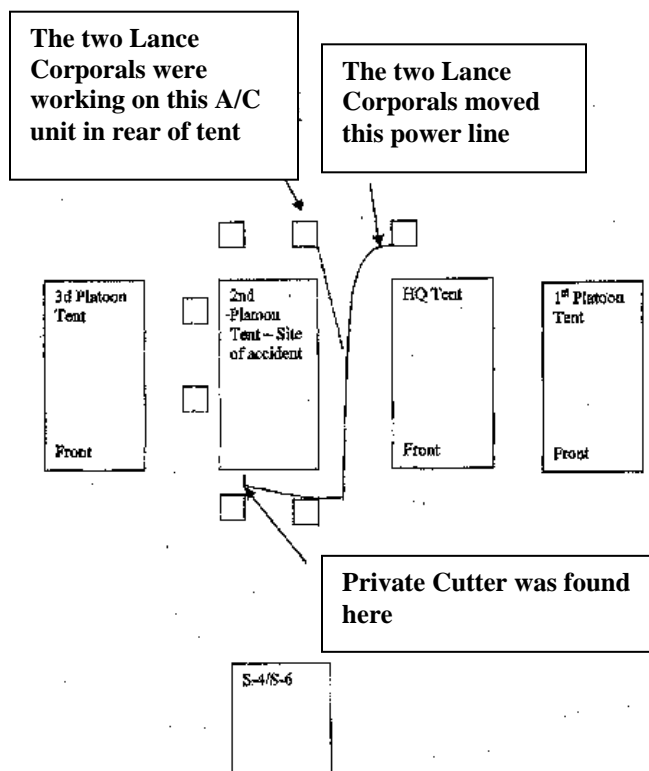
**Figure 6. Drawing Depicting Area Where
Private Cutter was Electrocuted
(From Army Report of Investigation)**

Private First Class Cutter died from electrical shock while using a metal tool and attempting to rewire an air conditioning unit to the breaker box and subpanel/junction box. Resuscitation attempts were unsuccessful.

Further action is not warranted. Corrective action was taken against the noncommissioned officer who requested Private First Class Cutter repair the air conditioning unit.

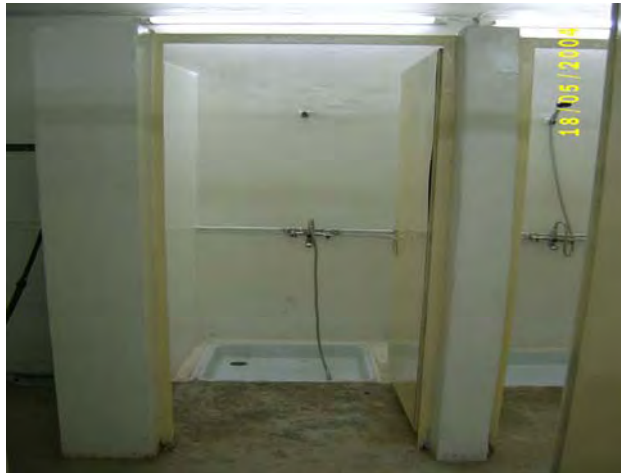
Figure 7. Shower Where Specialist Nolasco was Electrocuted (From Army Photographs)

(Note: An automatic water pump did not maintain water in water heaters, causing a heating element to rupture, resulting in electricity traveling through the metal water lines into the shower.)

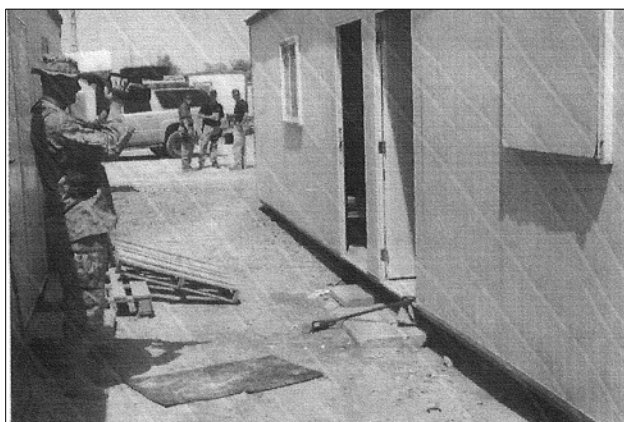
**Figure 9. Quarters Where Mr. Singh Was Electrocuted
(From Navy Photographs)**

The NCIS investigation determined that Mr. Singh or his roommate improperly installed an air conditioning unit sitting on the floor in Mr. Singh's living quarters. The electrical plug had been removed, and the wires "stripped and stuck" into an electrical receptacle connecting the neutral wire to a live feed, which caused the metal floor, walls and door to become electrified with 217.7 volts. Witness interviews revealed that Mr. Singh had been pouring water on his bare feet to rinse off dust immediately before attempting to open the door to his quarters, at which time he fell to the ground in a convulsion and became unresponsive. The investigation did not disclose any evidence of

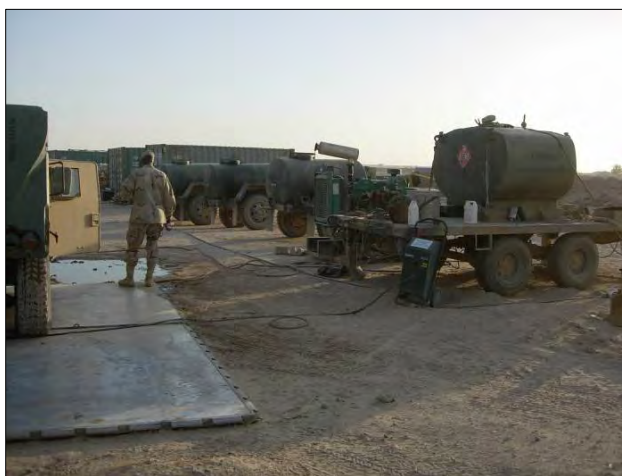
Figure 10. Area Where Sergeant Everett Was Electrocuted (From Army Photographs)

In early August 2005, a contractor moved an electrical generator to replace an ineffective diesel generator. The new generator provided power for various nearby activities, including a power washer used to clean vehicles. Almost immediately, a military member without electrical or generator training connected the power washer to the new generator. Over the next 2 weeks, people who used the power washer received electrical shocks, including Sergeant Everett and a member of the base's generator repair team. A military maintenance supervisor told the same generator repair team member (who had no formal training in electricity or generator repair) to ground the generator. The team member inserted a grounding rod and connected it to the generator. The power washer continued to shock Service members, and they reported it. On September 7, 2005, Sergeant Everett was electrocuted using the power washer to clean a vehicle.

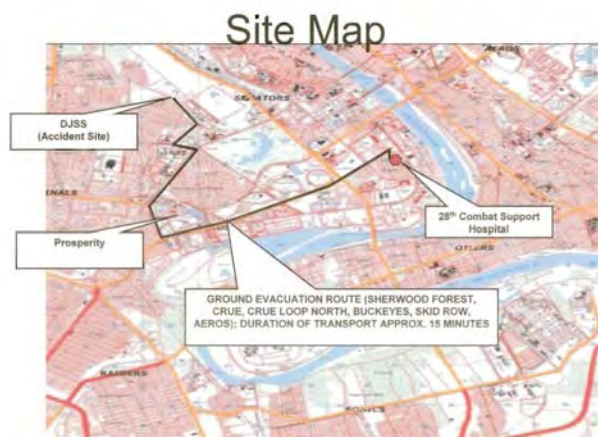
**Figure 12. Site Map Showing Area Where
Sergeant Montpetit Was Electrocuted
(From Army Report of Investigation)**
